Manhole Inspection Summary

Manhole # S35II1021MH

Insp Date: **6/13/07 9:13 AM**

Location Address: **4112 GREENWAY**

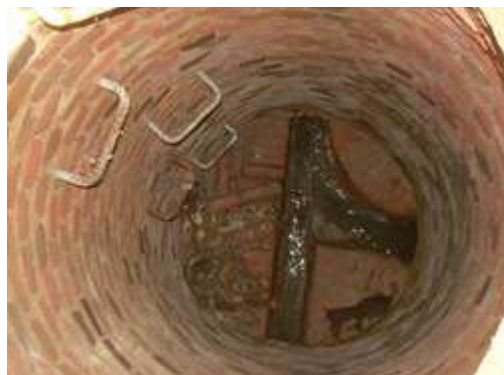
Top View

Corbel and Barrel infiltration. Corroded steps. Evidence of surcharge - Bench debris.

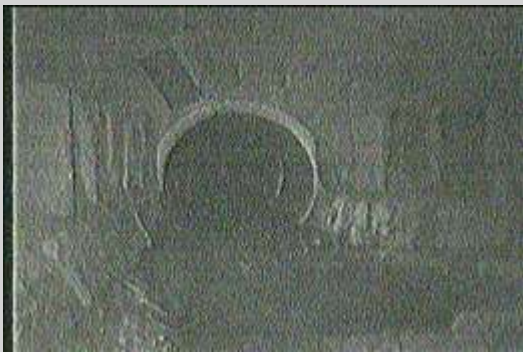
8 in. Circular Gravity Sewer Pipe Out @ 12 O'Clock

Infiltration: **None** Pipe Seal Cond: **Unknown**

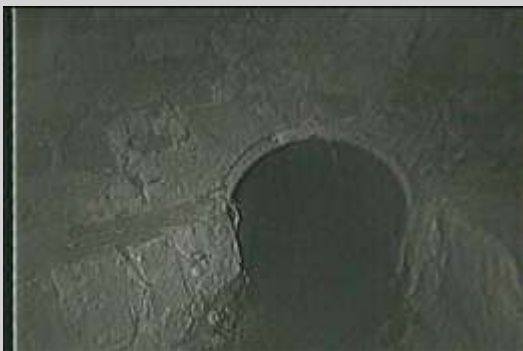
10 in. Circular Gravity Sewer Pipe In @ 3 O'Clock

Infiltration: **None** Pipe Seal Cond: **Cracked**

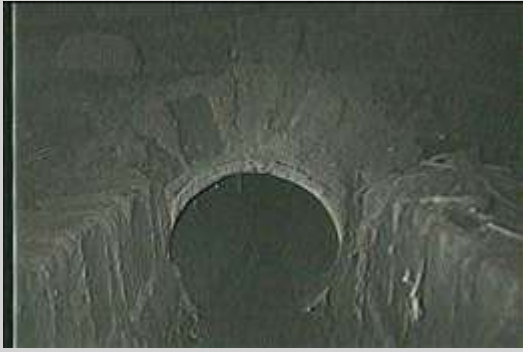
Pipe In @ 6 O'Clock

Infiltration: **None** Pipe Seal Cond: **Roots**

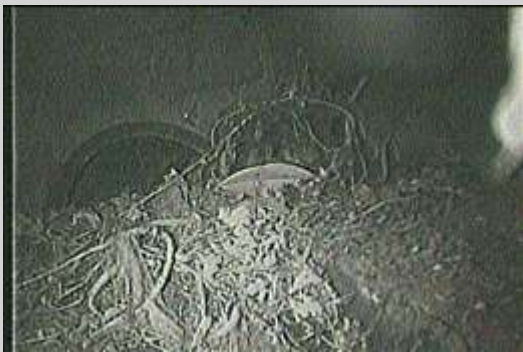
Pipe In @ 8 O'Clock

Deposits: ☐ None ☒ **Mud** ☐ Sludge ☒ **Debris** ☐ Grease

Silt Depth: **4** (in.) Deposits Extent: **Medium**

Infiltration: **Evidence** Pipe Seal Cond: **Unknown**

Connects To: **Stub connection / abandoned**
